PLUS  
**PAPAYA**  
Dental X-ray Imaging system

Panoramic  
Cephalometric  
Tomography

# New Concept / Multi-function Imaging System, PAPAYA PLUS

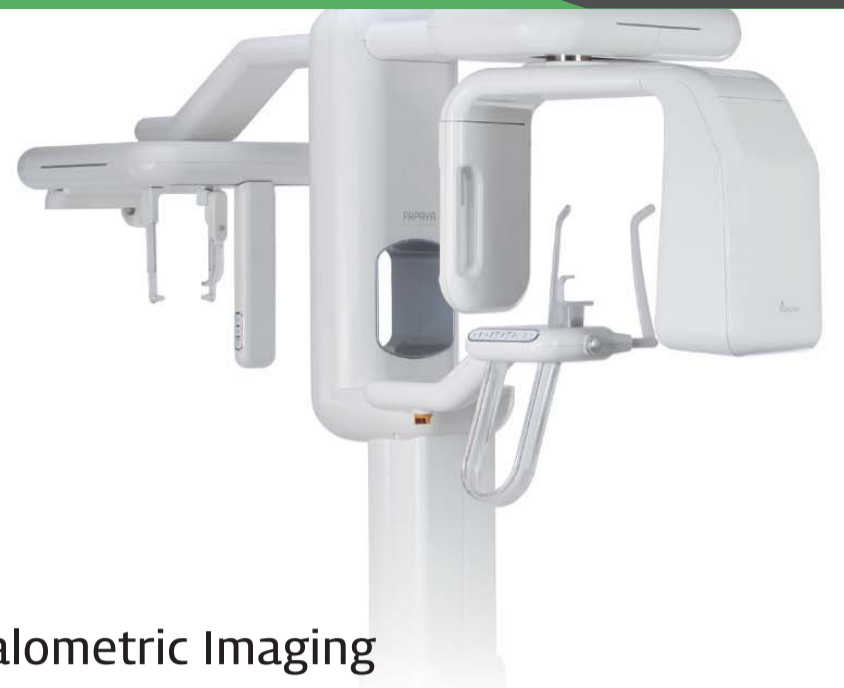
## Panoramic Imaging

- Papaya uses the CMOS sensor, which improves image quality while keeping radiation exposure to a minimum, Genoray has shown that it puts patient's safety first.

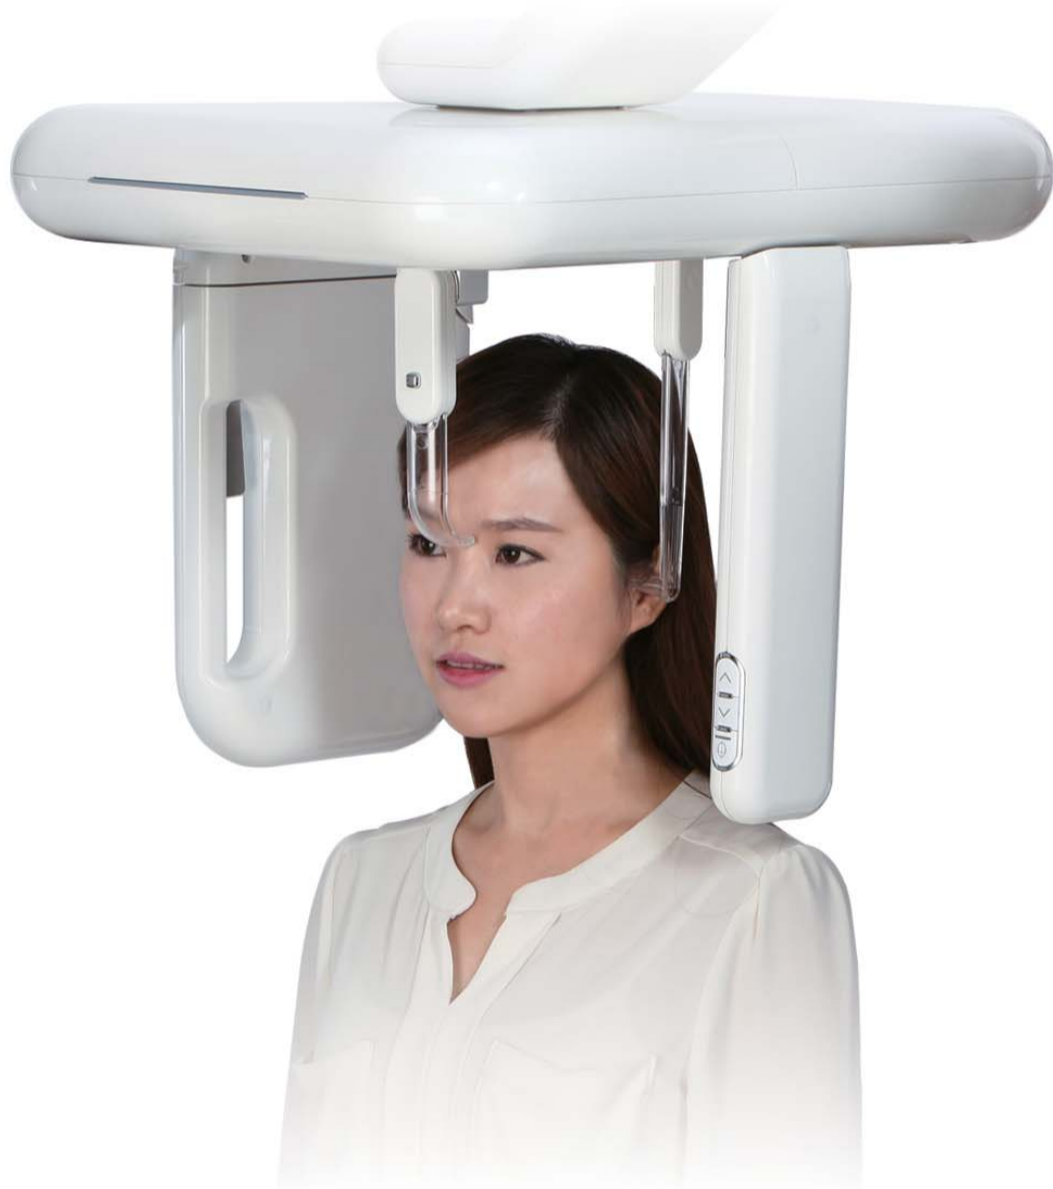
## Cephalometric Imaging

- When compared to the standard scanning method, PAPAYA PLUS has the shortest scan time.
- The short scan time reduces distortions caused by patient movement

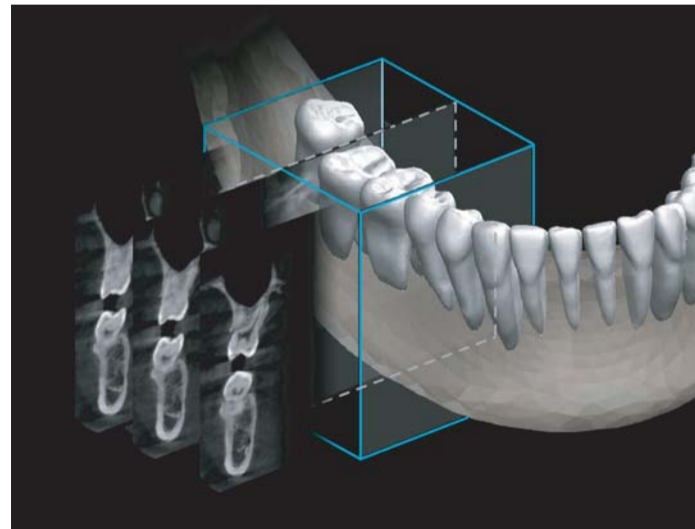
## Tomography Imaging (Optional)

PAPAYA can be upgraded without additional hardware to include the Tomography function.

- PAPAAYA provides true 3D imaging on the panoramic system.
- High image quality due to statistical reconstruction technique.
- 3D image has 256 cross-sectional slices having 0.195mm thickness and has FOV 5x5x10.3cm.

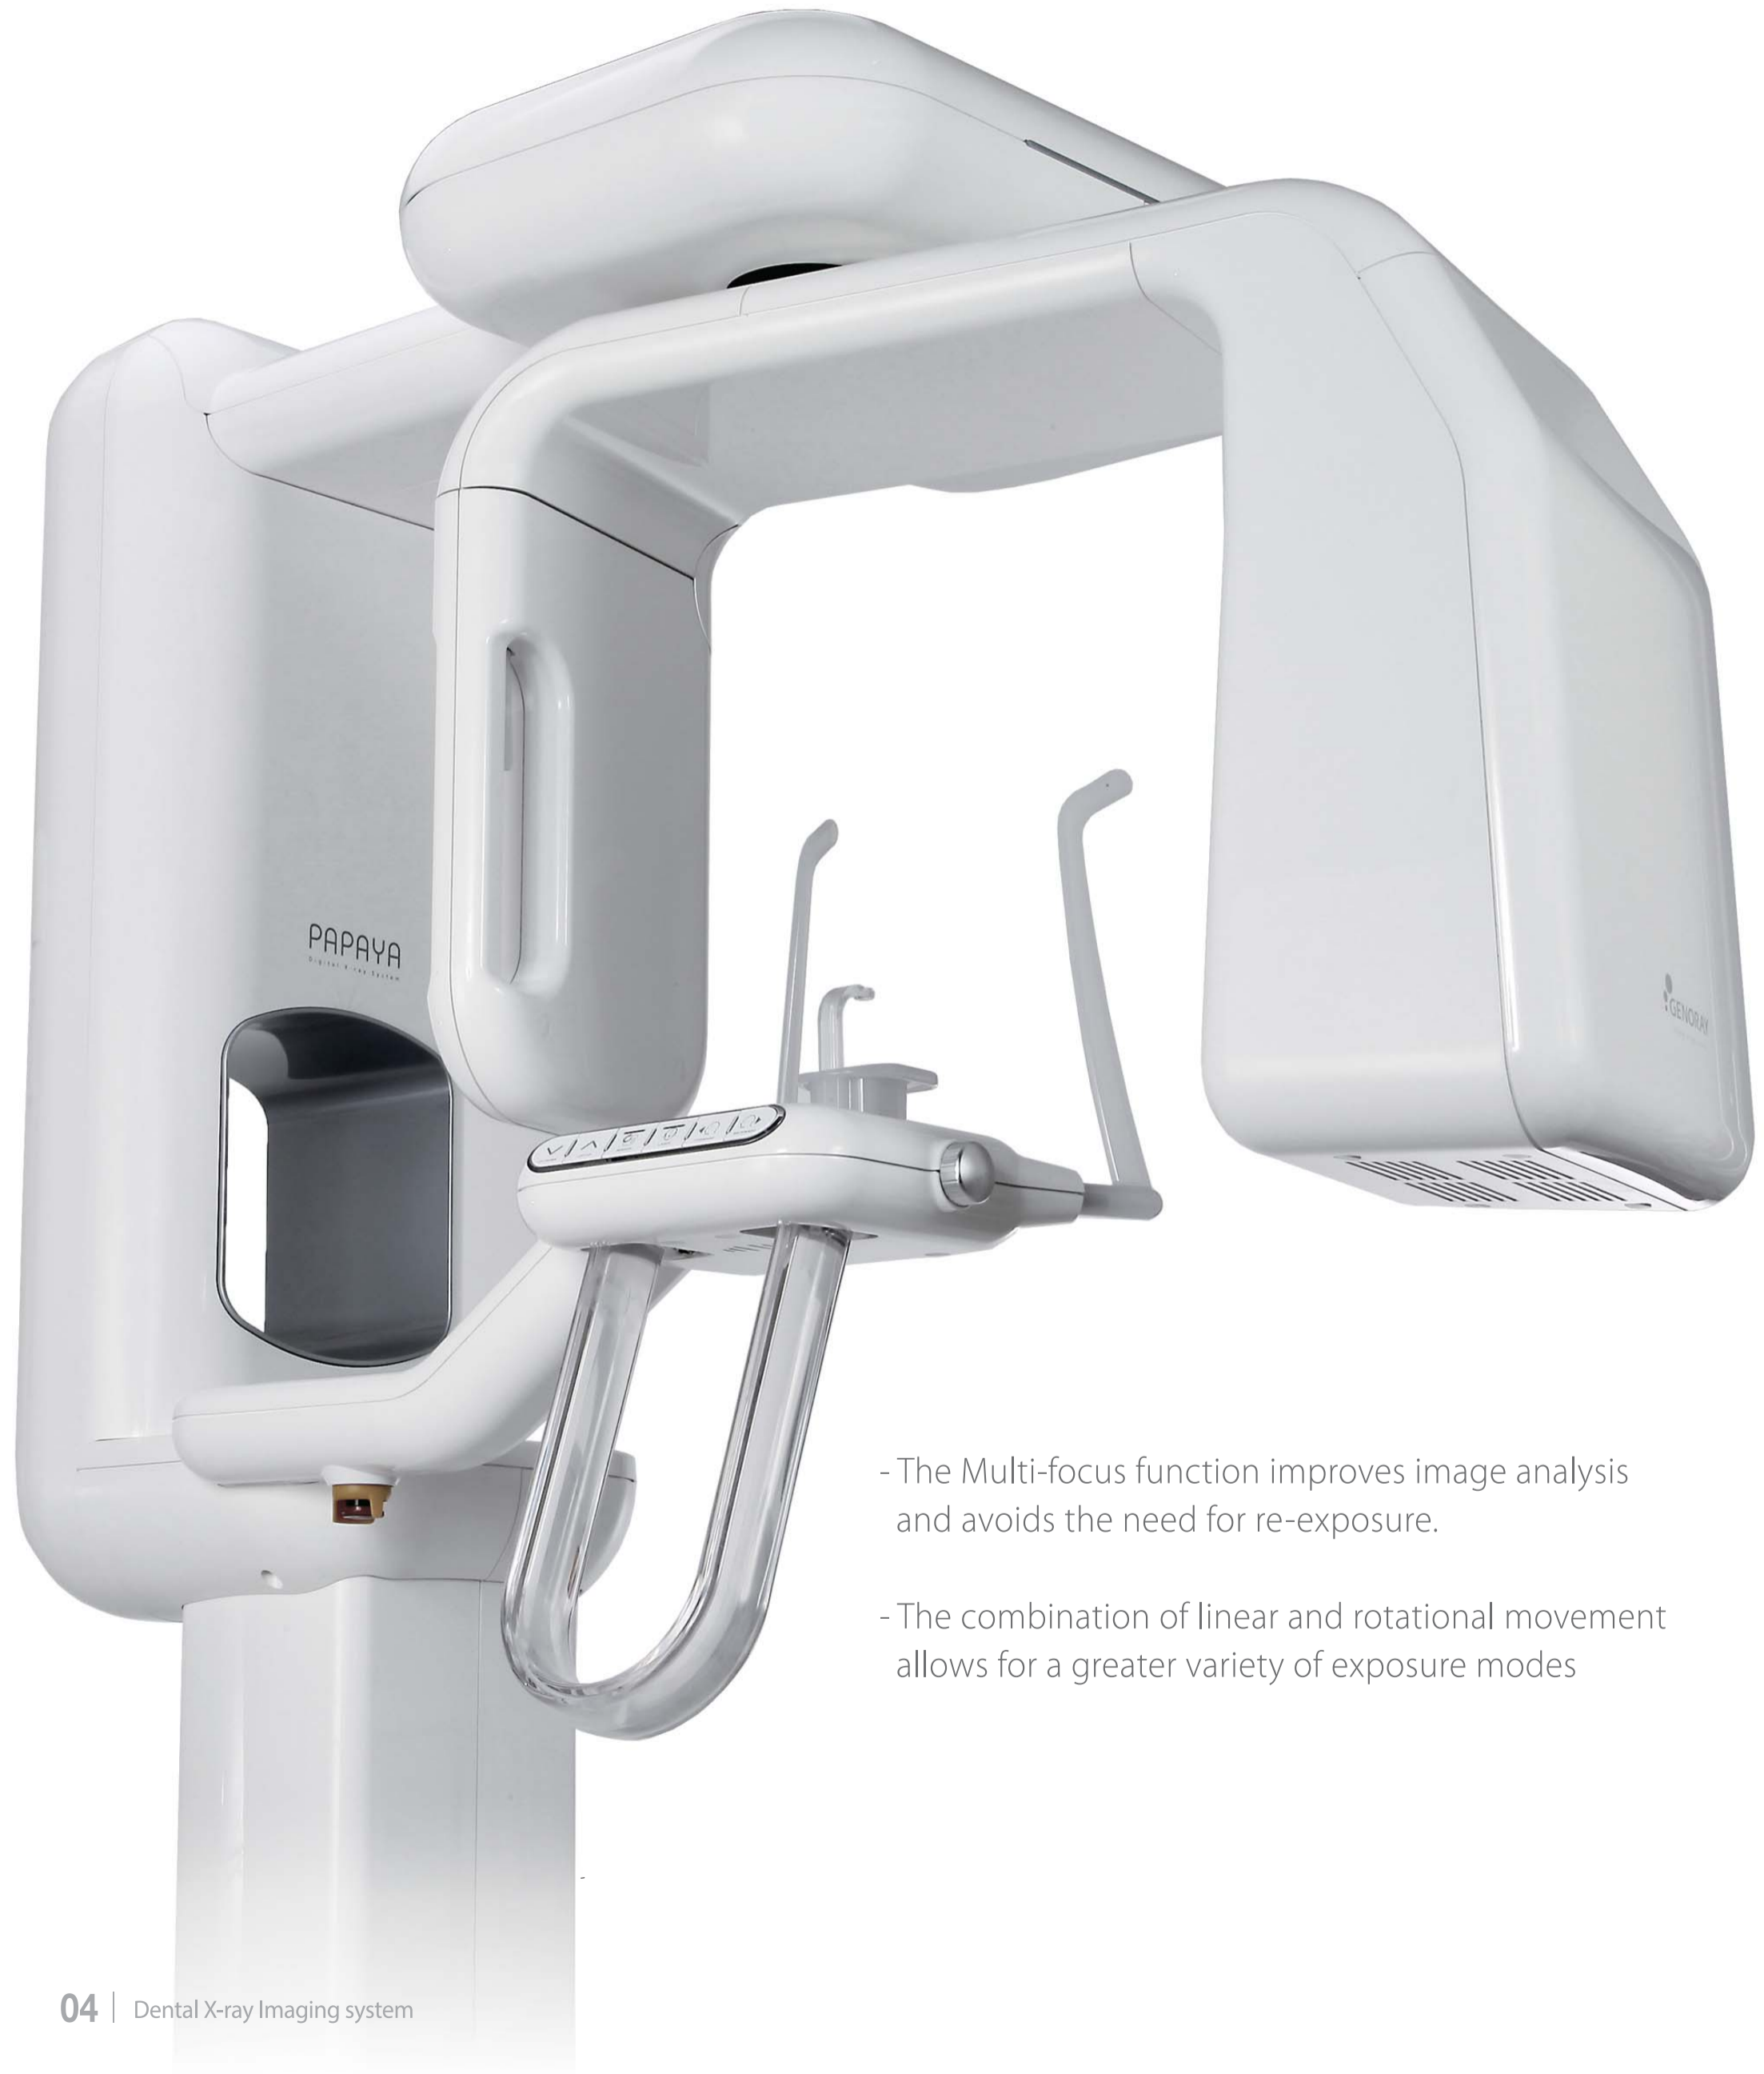
High Resolution Panoramic Image

- The Multi-focus function improves image analysis and avoids the need for re-exposure.
- The combination of linear and rotational movement allows for a greater variety of exposure modes

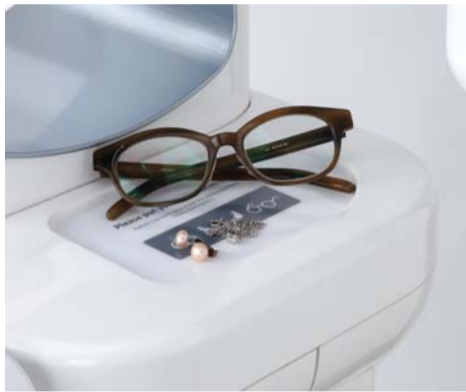
Convenient accessory tray

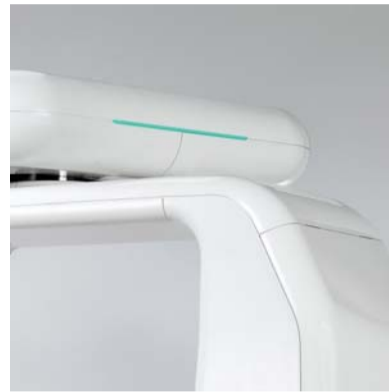
User friendly LED indication

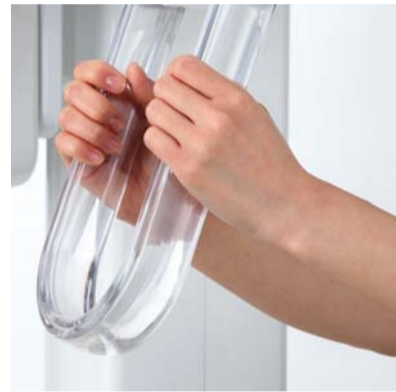
Comfortable hand grip

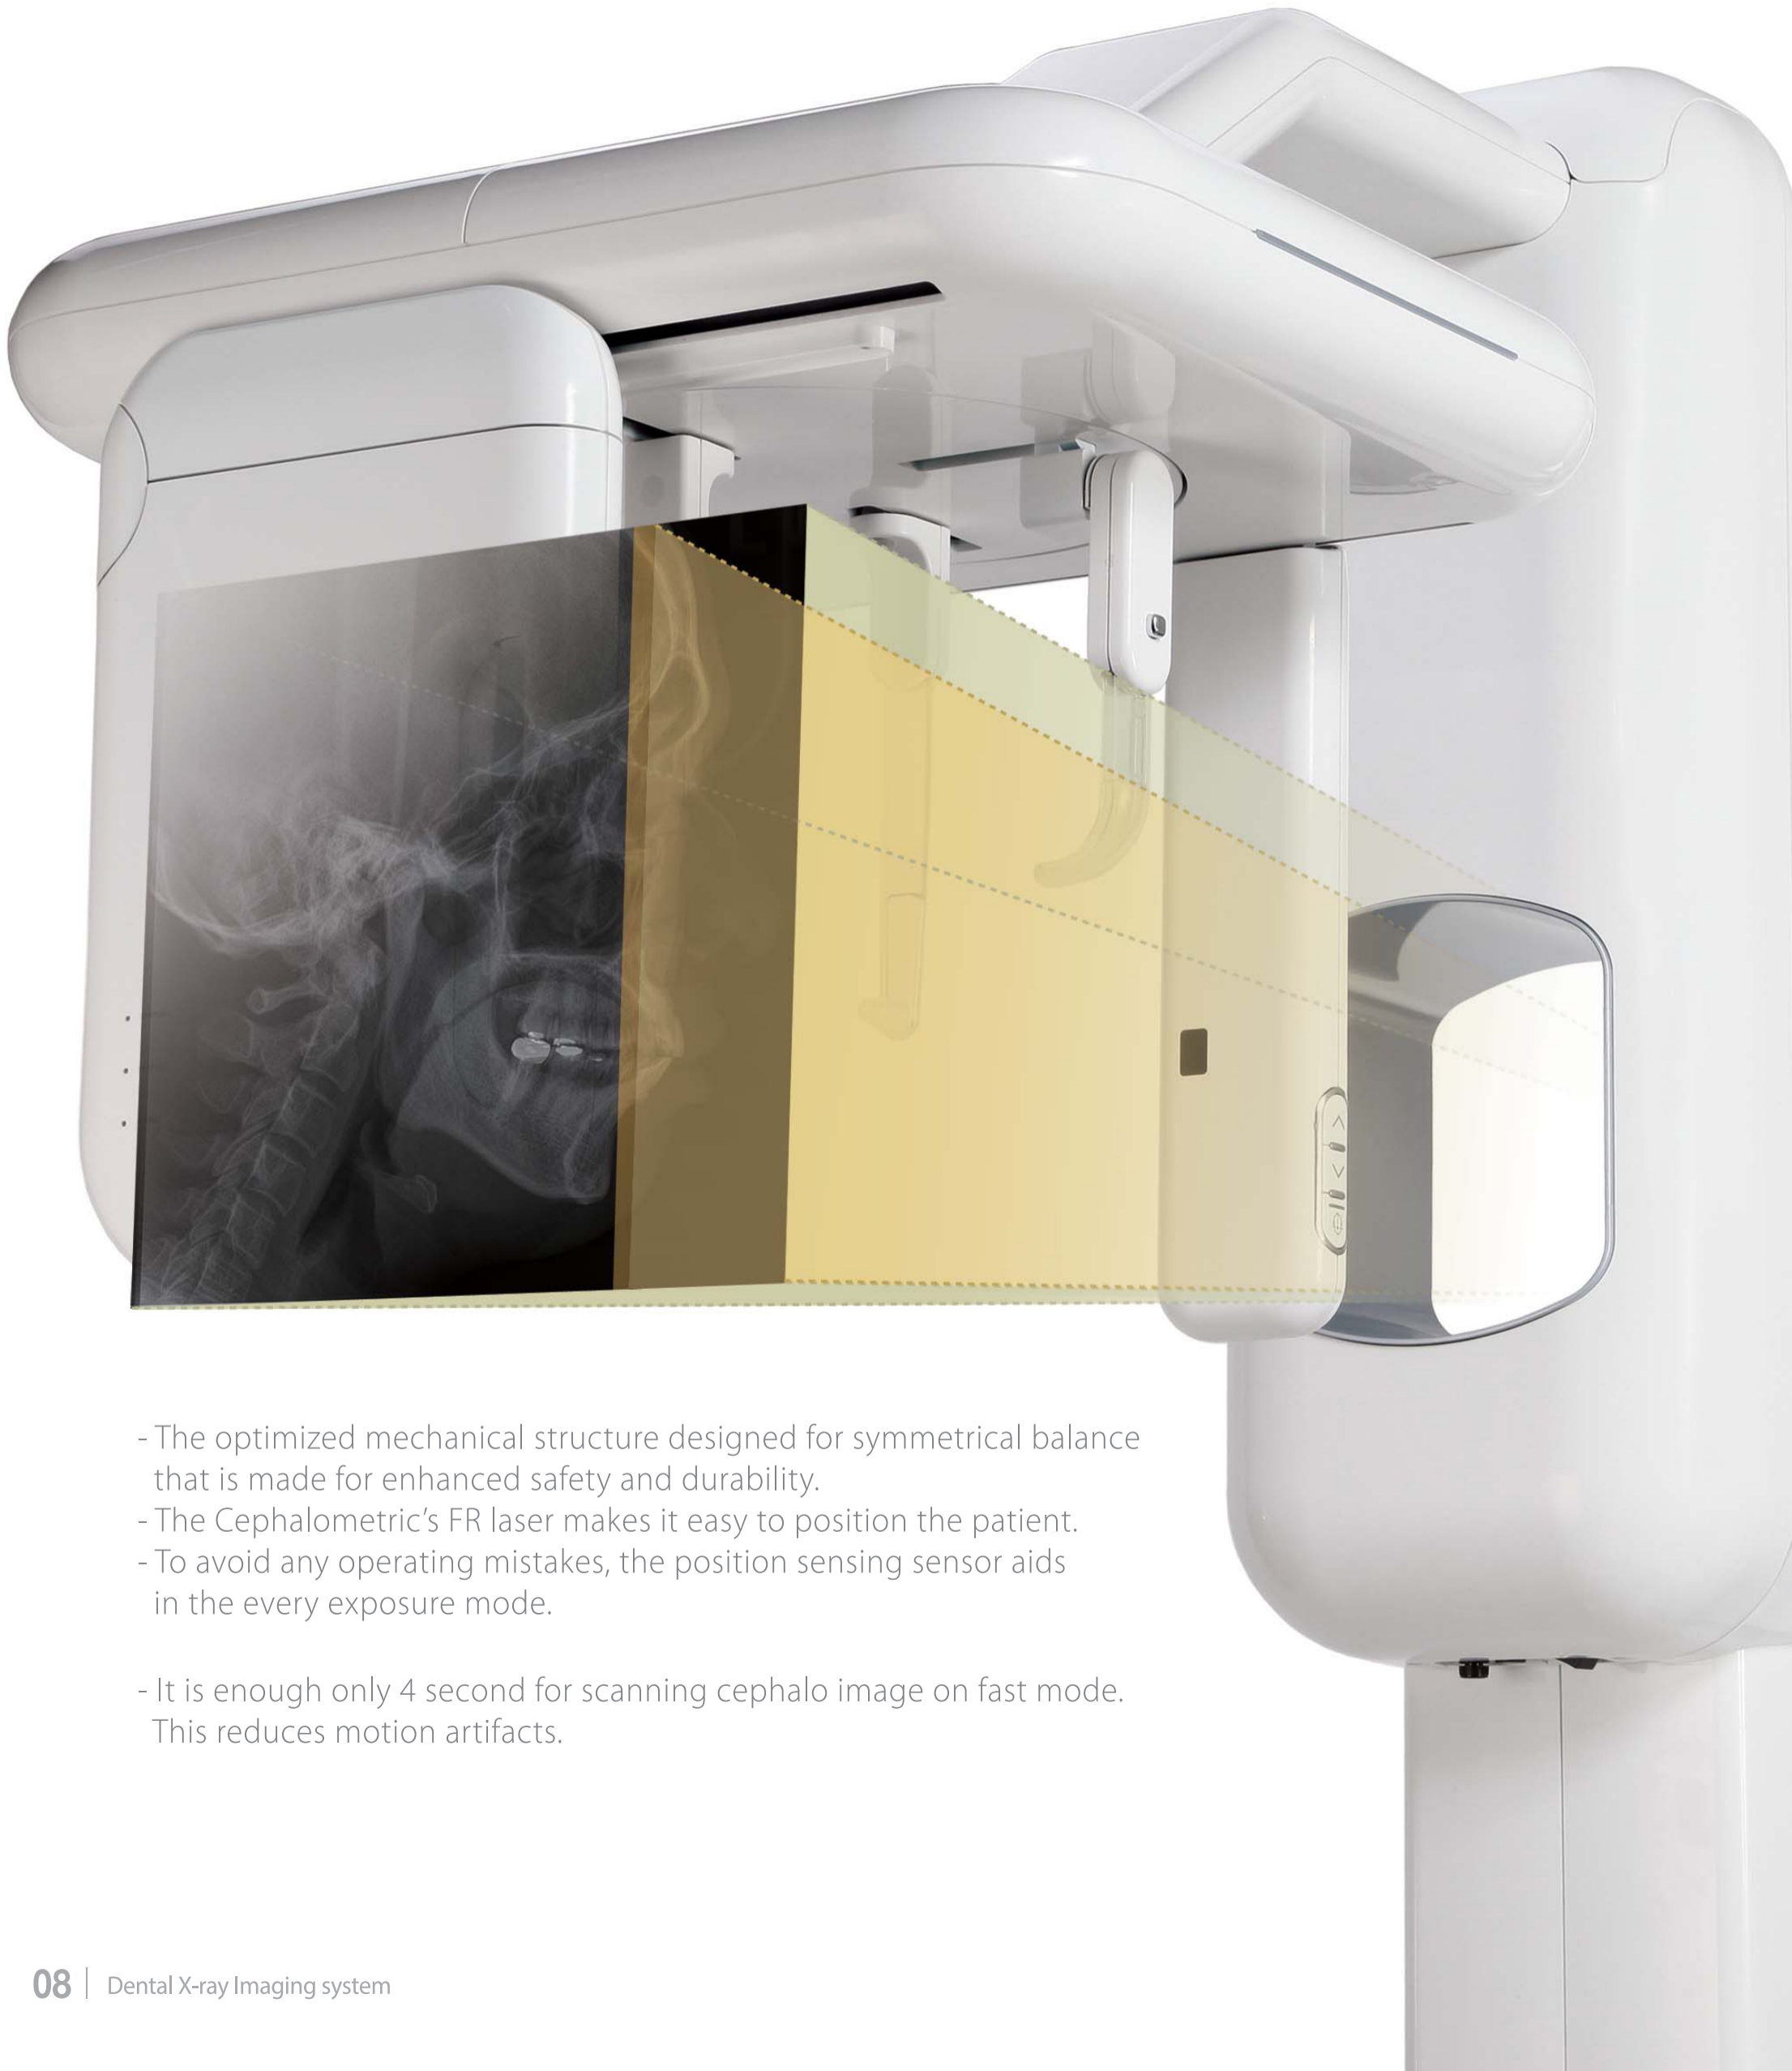
High Resolution Cephalometric Image

- The optimized mechanical structure designed for symmetrical balance that is made for enhanced safety and durability.
- The Cephalometric's FR laser makes it easy to position the patient.
- To avoid any operating mistakes, the position sensing sensor aids in the every exposure mode.
- It is enough only 4 second for scanning cephalo image on fast mode. This reduces motion artifacts.

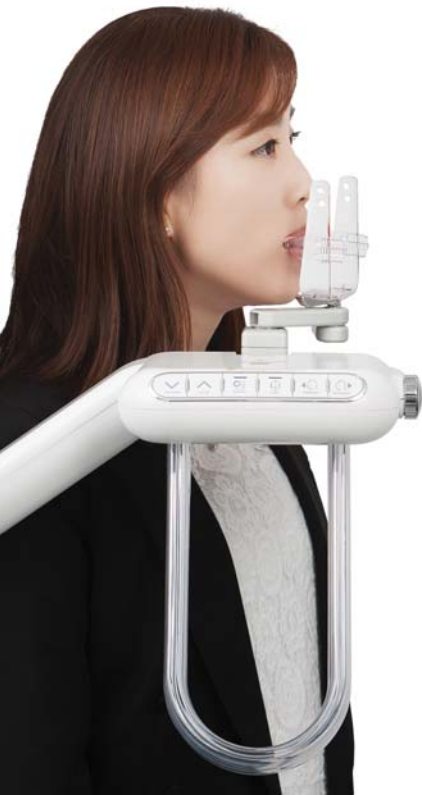
Dental Cross Sectional View

PAPAYA CUST is in a 3D imaging function that provides cross-sectional information for implant preparation.

- Complements the panoramic image, and provides a tomographic image required for implant planning.
- When planning the implant, CUST images help the patient understand the procedure.
- PAPAYA with CUST function is economical compared to CBCT.
